Integrity Engineering, LLC

CONFIDENTIAL INSPECTION REPORT

6 Newhome Place, Margate, NJ 08402

2/22/06 9:00 am to 12:00 pm

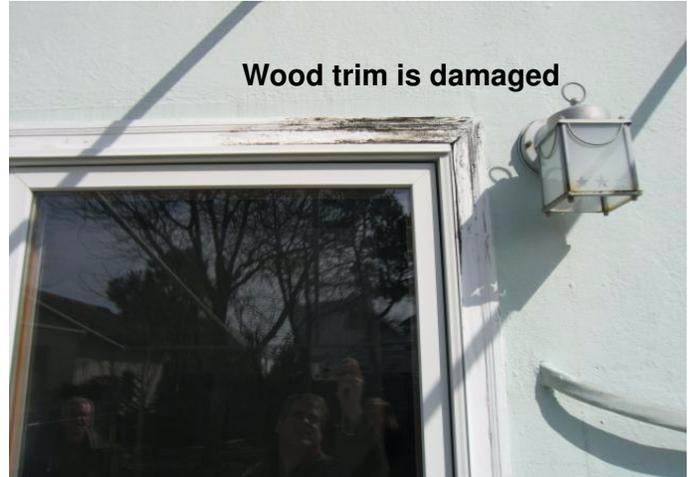
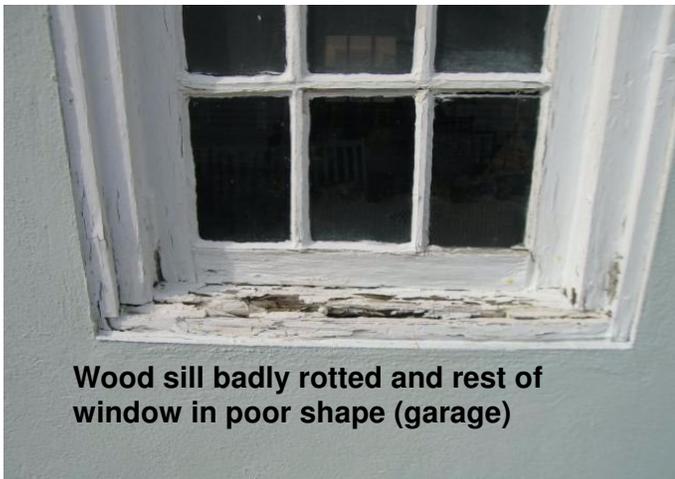
Sections of the fascia board or wood trim are weathered, and should be capped, repaired or replaced. In particular, the end rake board (end wood rafter not resting on home) needs to be replaced as it is damaged in two sections.

Figure Set - 1 Sections of the fascia board or wood exterior trim are weathered and should be serviced

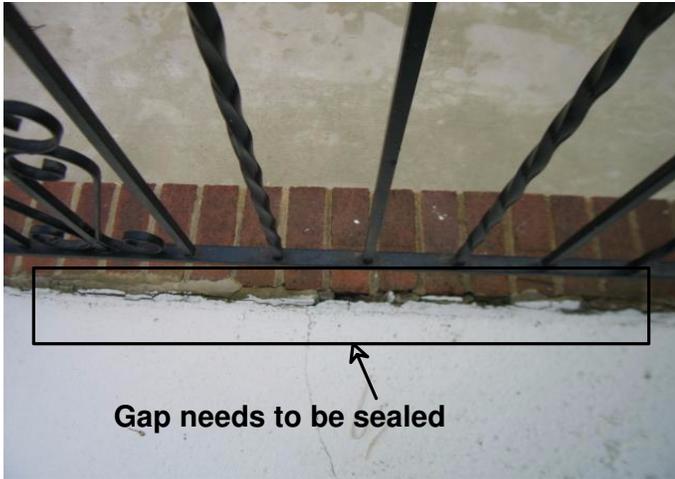
Figure Set - 3 The front porch brick edging needs to be sealed where it adjoins the concrete pad to keep out water

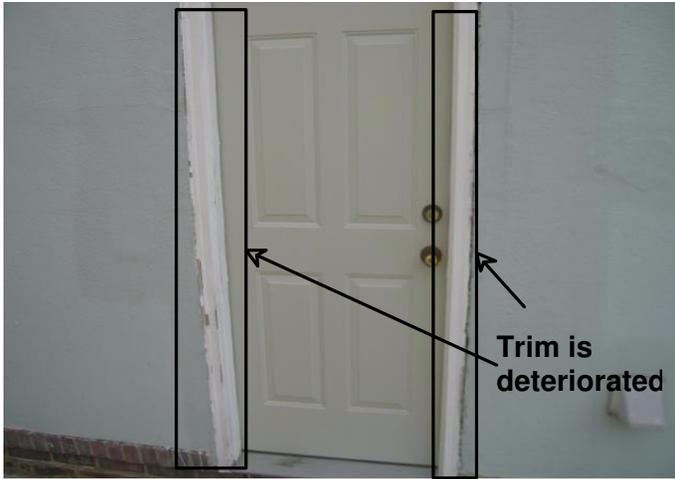
The side door trim was deteriorated and will need to be capped or replaced.

Figure Set - 6 The side door trim was deteriorated and will need to be capped or replaced

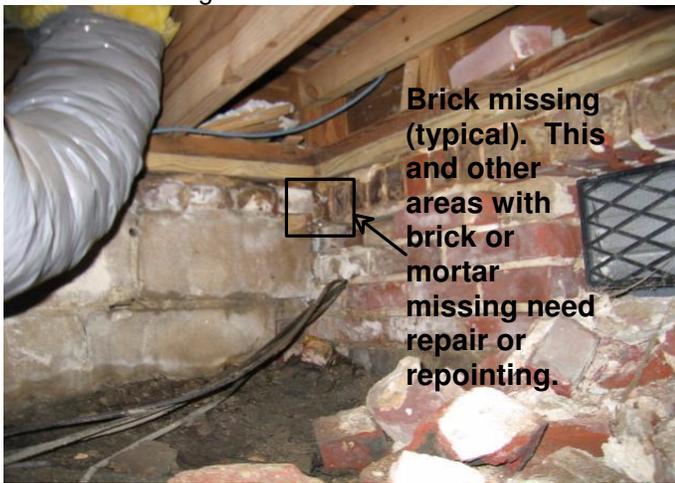
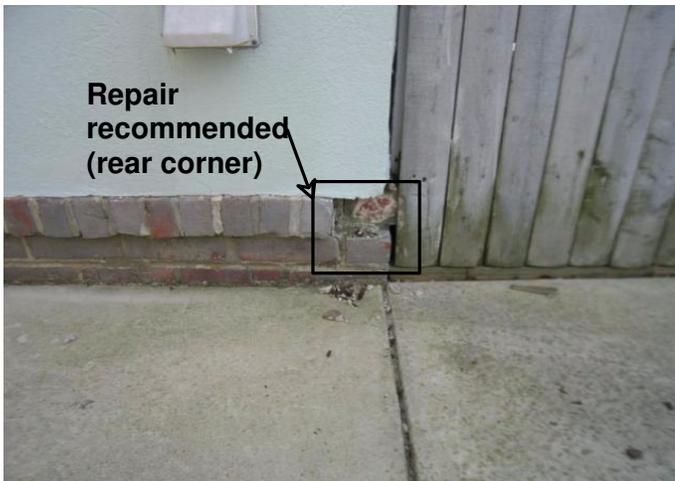
A few areas of the brick foundation wall have missing bricks and mortar requiring repair.

Figure Set - 7 A few areas of the brick foundation wall have missing bricks and mortar requiring repair

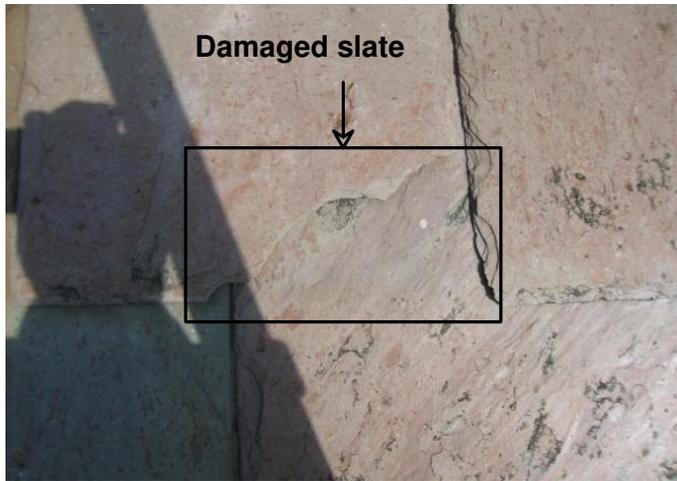
One slate was damaged on the rear of the roof but this does not appear to have impaired the integrity of the roof.

Figure Set - 8 One slate was damaged (rear roof) but this does not appear to impair the integrity of the roof

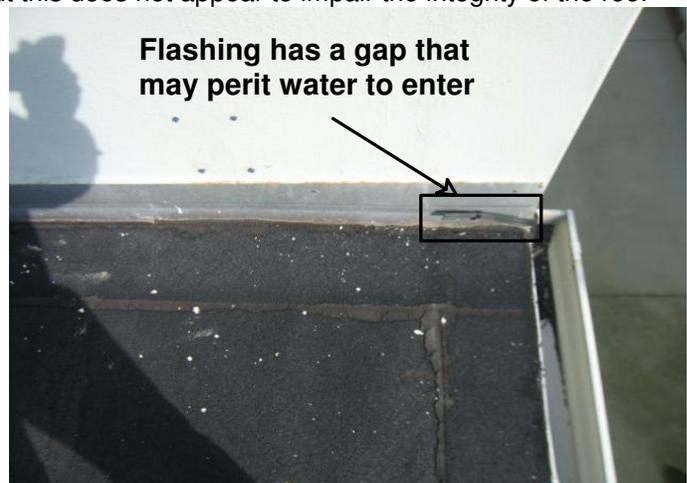
The roof has a flat-roofed addition, and flat roofs can be problematic if they are not maintained. Water will pond on most of them, and only be dispersed by evaporation, and they must be kept clean and inspected regularly. However, this flat roof needs serviced for the following reasons: There are air pockets below the asphalt roll roofing indicating a poor adhesion of the roofing material to the roof deck, and the seam where the drip edge meets the roll roofing (along the perimeter) exhibits gaps on both corners where water may be able to enter. I recommend that a qualified roofing contractor be consulted to repair the defects found, and while there, check the overall condition of the flat roof area since the roof deck below the roll roofing material cannot be evaluated exclusively by visual inspection.

Figure Set - 9 The roof has a flat-roofed section with large raised air pockets and drip edge which requires service

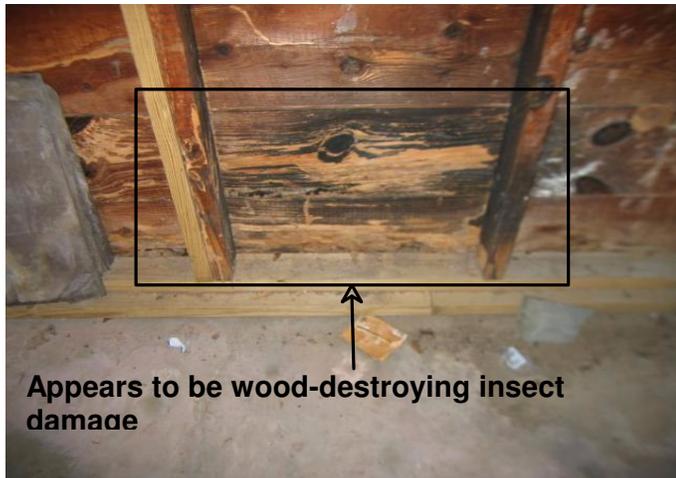
Figure Set - 13 There is evidence of wood-destroying insect damage on the rear & left side wall sheathing
